# **Meaford Wastewater Treatment Plant Class Environmental Assessment**

Technical Memorandum  
WWTP Condition Assessment

January 2022

PROJECT NO. 121027

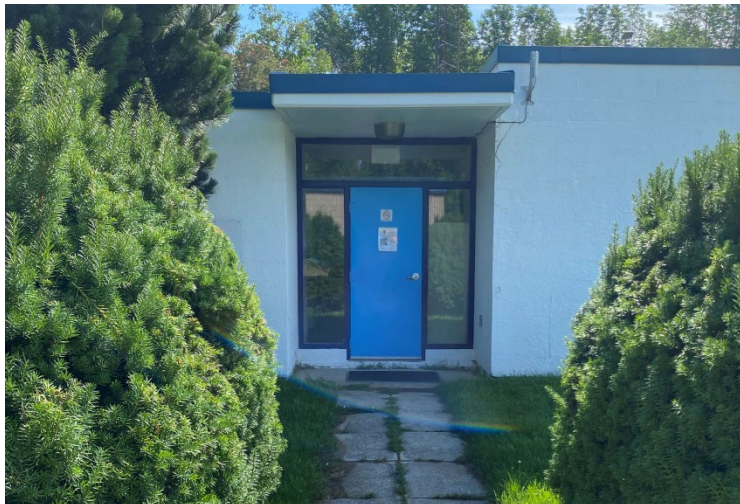
**Figure 2 – WWTP Administration Building**

- Site Works
  - The property line fencing appears to be in good condition.
  - The asphalt driveway is in good condition.
- Structural

- Administration Building roof membrane is in poor condition, based on discussion with Operations staff. It is recommended that the roof membrane be refurbished within the next five (5) years. The cost to refurbish a roof membrane is estimated to be \$25,000.

- The exterior and interior walls, windows, doors and interior tile flooring appear to be in moderate condition. The Administration Building is dated with limited working space. Operations noted that due to the lack of space in the building, the existing workshop has been repurposed as a meeting room. It is recommended that the Administration Building undergo some renovations and build a new office area in a new building proposed for the upgrades. The estimated cost for the building's refurbishment is \$300,000.

- Building Mechanical
  - The Administration Building is not equipped with air conditioning. It is recommended to upgrade the building with a new heating and cooling system. The cost to outfit the Administration Building is estimated to be \$432,000.

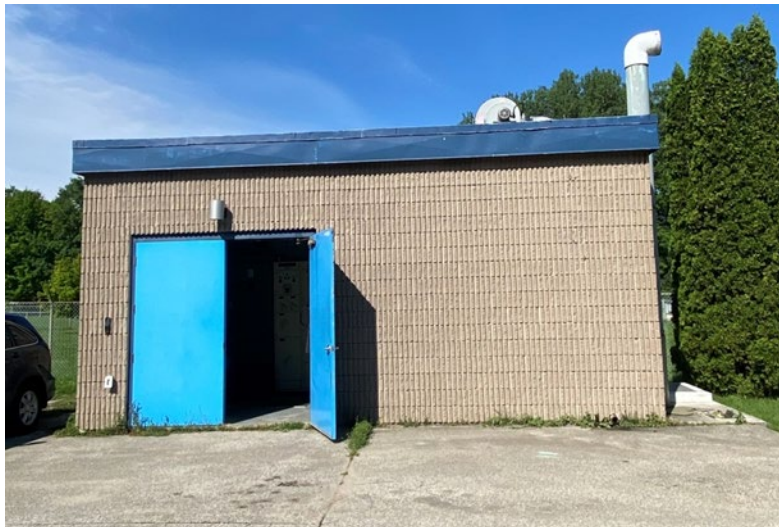
**Figure 3 – Raw Sewage Pumping Station**

- Structural
  - The SPS#2 structure appears to be in good condition. There are no upgrades recommended for the station at the time of inspection.
  - The SPS#2 has a 3.66m x 4.2m x 15m (approximate) concrete wet well. A visual inspection of the wet well was not completed at the time of inspection. However, operations staff confirmed that the concrete in the station appears to be in good condition.
- Process Mechanical

- The SPS is equipped with two (2) Flygt 65hp chopper raw sewage pumps that are equipped with electrically driven motors and VFDs. Each pump and motor set were replaced in 2019 and is rated at 145L/s with a TDH of 19m. The raw sewage pumps are located within a confined space and could not be visually inspected. However, due to the age of the equipment, there are no recommended upgrades for the raw sewage pumps.

- The four (4) wet well sluice gates have seized in the open position. The Municipality has planned for the replacement of the sluice gates prior to this inspection.

- The onsite SPS has a 450mm diameter emergency overflow pipe that runs from the station to maintenance hole #20041 and discharges into the Nottawasaga Bay. The approximate length of the overflow pipe is 200m. Buried piping was not visually inspected during this site inspection; however, a desk top review of the piping was conducted. Operations staff confirmed that the original yard piping has not been replaced since its installation in 1978. Buried piping has an estimated useful life of 80 years. The estimated remaining useful life of the buried piping is 30 years. The cost of replacement is around \$340,000.

- The raw SPS has a discharge forcemain with a diameter of 350mm and is equipped with a bypass connection. The forcemain length from the station to the Meaford WWTP Influent Works is approximately 75m. The desk top review of the buried piping indicate that the original yard piping has not been replaced since its installation in 1978. Buried piping has an estimated useful life of 80 years. The estimated remaining useful life of the buried piping is 30 years. The estimated replacement cost is about \$100,000.

- **Building Mechanical**
  - The hoist for the pumps is in poor condition. The Municipality has arranged for the hoist's replacement for this year prior to this inspection.

- The HVAC system for the raw sewage pumping appeared to be in good condition. No upgrades were recommended upon inspection.
- **Power, Instrumentation & Controls**

- Each pump and motor set are equipped with a Benshaw VFD. The VFDs were installed with the 2019 station upgrades. The VFDs appear to be in good condition with no recommended upgrades at the time of inspection.

- A strap on Endress+Hauser 91W Transit-Time flow meter was also installed in 2008. The flow meter appears to be in good condition.
  - The MCC for the sewage pumping station was originally installed in 1978 and upgraded in 2008 with VFDs. The MCC appears to be in good condition.

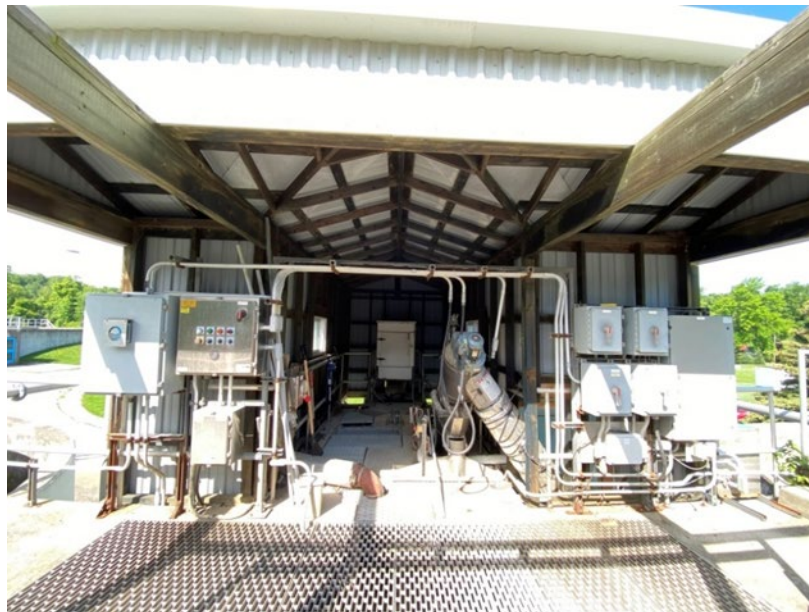
**Figure 4 – Influent Works**

- Structural
  - The structural concrete of the two (2) influent screen channels appears to be in fair condition.
- Process Mechanical
  - The first screen channel is equipped with an automatic fine screen that has 3mm openings. The automatic screen has a rated peak instantaneous flow rate of 100L/s. The automatic screen was installed in 2005 and appears to be in fair working condition. Operations noted that there have been minor issues with the automatic bar screen due to excessive rags. There are no recommended upgrades at the time of inspection.

- The second screen channel is equipped with a manual coarse bar screen with 25mm bar spacing. The bar screen has a rated peak instantaneous flow capacity of 328L/s. This screen was installed in 2005 and appears to be in fair condition. Maintenance of manual bar screens can be labour -intensive and it is recommended to update the manual bar screen to an automatic screen within the next five (5) years. The cost to upgrade the manual bar screen to an automatic screen is \$150,000, assuming major structural changes are not required.

- The Influent Works is also equipped with one (1) transport screw conveyor, complete with a bagging system and a disposal bin. The screw conveyor and grit disposal system were installed in 2005 and appears to be in moderate condition. It is recommended that the screw conveyor be replaced within the next 20 years. The estimated cost to replace the screw conveyor is \$80,000.

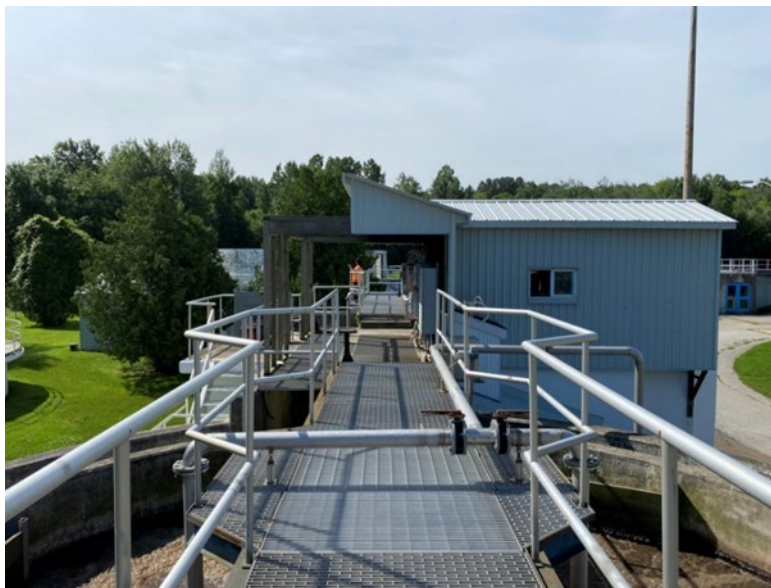
**Figure 5 – Aeration Tank**

- Structural
  - There are two (2) concrete aeration tanks with an internal diameter of 10.9m and a side water depth (SWD) of 5.9m. The concrete tanks were originally constructed in 1969. There has been concrete rehabilitation over the years. Upon visual inspection, the tanks appear to be in moderate condition. The tanks' exterior has been parged in the past with no rehabilitation work to the interior walls. The concrete tanks are 53 years old and typically have an expected useful life of 100 years. It is recommended that the Municipality continue their maintenance efforts over the remaining useful life of the tanks.

- Air piping for the aeration tanks is routed over the cat-walk creating a tripping hazard. It is recommended that a small set of steps be provided over top of the piping to reduce the potential for tripping. The cost to install stairs over the piping is estimated to be \$5,000.

- Each aeration tank is fitted with aluminum stairs and guard rails. Upon inspection, it was observed that the guard rails do not meet the height requirements outlined in the Ontario Building Code (OBC). It is recommended that the guard rails—complete with kick-plates—

be replaced within the next five (5) years. The estimated cost to install OBC compliant guard rails with kick-plates is \$10,000.

- The aeration tanks are each equipped with a fine bubble aeration system. The aeration system was originally constructed in 1969 with upgrades to a fine air bubble diffuser system in 2005. There are 220 evenly distributed 225mm diameter fine pore membrane diffuser discs at the bottom of each tank. Operations Staff indicated that the diffusers are replaced every two (2) years on an as -needed basis when the aeration tanks receive their routine maintenance. It is recommended that the Municipality continue their existing maintenance regime.

- Due to the absence of a grit removal system, approximately 1m of grit accumulates between tank clean-outs, which are completed every two (2) years. The removal of grit is a labour-intensive and time-consuming process. It is recommended that a grit removal system be added upstream of the aeration tanks as a component of expansion efforts to alleviate maintenance costs. The estimated cost is \$300,000 based on using Vortex Grit Removal System, an additional \$300,000 is assumed for an enclosure.

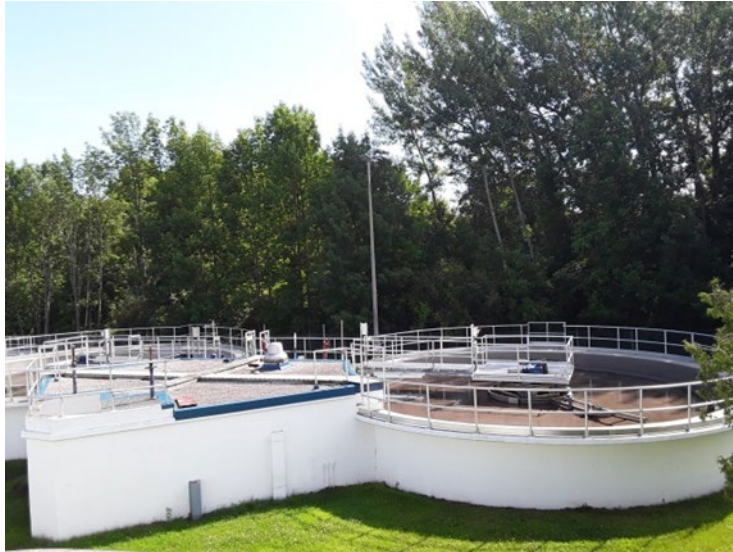
**Figure 6 – Secondary Clarifier**

- **Structural**
  - There are two concrete up-flow secondary clarifiers that have an internal diameter of 12.2m and 2.9m SWD. Each clarifier has a volume of 339m<sup>3</sup>. The two clarifiers were constructed in 1969 and appear to be in moderate condition. The two clarifier tanks recently had resurfacing work completed on the interior and continuing work on the exterior, including grout injection and parging. Despite rehabilitation efforts, cracking is still visible in the exterior concrete. It is recommended that the Municipality maintain their rehabilitation efforts.

- Each clarifier is fitted with aluminum stairs, guard rails and walkway. The aluminum stairs, guard rails and walkway appear to be in good condition.

- **Process Mechanical**
  - Two (2) motors, each equipped with a VFD, are used to control the sludge and scum removal drive mechanisms, one motor for each clarifier tank. The motors were replaced in 2018 and appear to be in good condition. There are no recommended upgrades for the sludge and scum removal mechanism motors at this time.

- Each clarifier is equipped with a sludge removal mechanism at the base of the tank, and a scum removal mechanism which removes scum from the water surface. The sludge and scum removal mechanisms were replaced in 2018. What could be seen of the drive units and removal mechanisms were observed to be in good condition. There are no recommended upgrades for the sludge and scum removal mechanisms.

- **Power, Instrumentation & Controls**
  - The clarifier controls were moved to outdoor panels in 2019. The exterior panel enclosure is stainless steel, which gets hot during the hours it is in direct sunlight. The Municipality has since installed a cooling unit to the side of the cabinet to keep it cool. Operations staff indicated that over the summer months, the cooling system was adequate in keeping the

control panel from over-heating. The controls and exterior panel appear to be in good condition despite the temperature issues. It is recommended that the Municipality continue to review the operability of the controls during the summer months, if the cooling unit is unable to maintain a reasonable temperature the Municipality should consider a small structure to provide shade.

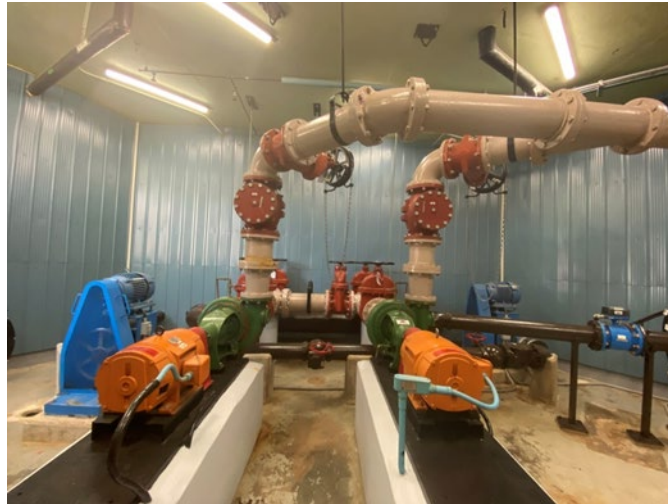
**Figure 7 – RAS and WAS Pumps**

- Structural
  - Sludge control room is clean and in good condition; no upgrades are recommended at this time.
- Process Mechanical
  - The sludge pumping room is equipped with two (2) RAS pumps with flow capacities of 45L/s. Each pump is equipped with an electrically driven motor. The pump and motor sets were initially installed in 1969, with RAS pump #1 being replaced in 2014 and pump #2 being replaced in 2009. RAS Pump #1 appears to be in moderate condition and was observed to be making noises during operation. RAS Pump #2 appeared to be in good condition. One spare is in stock due to the long lead time. It is recommended that both RAS pumps be replaced within the next five (5) years, and 18 years respectively with VFDs installed. The cost to replace both of the RAS pumps and motors is estimated to be \$110,000.

- There are two (2) WAS pumps and motor sets, each with a flow capacity of 23L/s, that were installed with the 1996 plant upgrades. The WAS pumps were observed to be in good condition, but have approached the end of their expected useful life. It is recommended that the WAS pumps and motors be replaced within the next five (5) years. The estimated cost to replace the two WAS pump and motor sets is \$60,000.

- The two (2) inlet sluice gates from the clarifiers to the WAS and RAS pumping system are in poor condition. Operations staff indicated that the gates are a logistical challenge to replace. It is recommended that the inlet sluice gates be replaced within the next five (5) years. The cost to replace the sluice gates is estimated to be \$50,000. However, the complications caused by the lack of redundancy and need for temporary works to facilitate construction

could result in installation costs much in excess of the typical costs for replacement. Bypass pumping would likely be required for a one-month period at an estimated cost up to \$200,000.

- Power, Instrumentation & Controls
  - Khrono RAS and WAS flow meters were initially installed in 1996. The flow meter is in good condition, however due to the age of the asset it is recommended that it be replaced within the next five (5) years. The cost to replace the RAS/WAS flow meter and digital readout is estimated to be \$10,000
  - The MCC for the RAS/WAS facility was originally installed in 1969. This MCC is at the finished stage of being replaced in 2022.

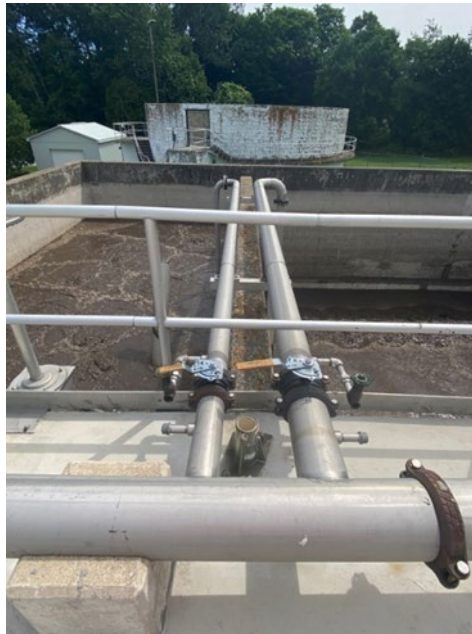
**Figure 8 – Aerated Digester**

- Structural
  - The WWTP has one (1) two-stage aerobic digester. The Stage 1 digester tank is approximately 9.5m x 10m x 4.35m deep, and the Stage 2 digester is approximately 4.9m x 10m x 4.35m deep. The combined capacity of the tanks is approximately 626m<sup>3</sup>. What could be observed of the concrete tanks was in poor condition. Immediate refurbishment is required for the interior and exterior of the digester tanks. Injection grouting was installed in 2019 to rehabilitate the storage tanks. The cost of injection grouting and parging the tanks is estimated to be \$57,000.

- There is one (1) two-celled sludge storage tank that was constructed in 1995 as part of the digester upgrade. Each cell of the tank is approximately 18m x 14.75m x 4.35m deep, with a total storage volume of 2,300m<sup>3</sup>. The sludge storage tanks have a treatment capacity of 3,910m<sup>3</sup>/d, as outlined in the 2015 Master Plan. The concrete tanks have significant visible cracking throughout the concrete at 1–2-meter intervals. Immediate refurbishment is

required for the interior and exterior of the storage tanks. Injection grouting was installed in 2019 to rehabilitate the storage tanks. The cost of injection grouting and parging the tanks is included in the cost for parging and grouting the aerobic digester above.

- The digester is fitted with aluminum stairs, guard rails and walkway. The metal walkway is used to provide support for the aeration piping and provide access to the tank from above. The aluminum stairs, guard rails and walkway appear to be in good condition. There are no recommended upgrades to the aluminum guard rails and walkways at this time.

- **Process Mechanical**
  - The two-stage aerobic digester is equipped with a coarse bubble diffused aeration system. The aeration system was installed in 1996, with diffuser maintenance scheduled with digester tank cleaning every two years. Operations staff indicated that the aeration system is in good condition, however it does not have backflow prevention for when the aeration system is not on.

- The digesters air diffusers are fed by two (2) blowers and motors. The blower and motor sets were installed in 1996 and appear to be in good condition. Blowers have a useful life of approximately 50 years, it is recommended that the blowers are replaced within 25 years. The estimated cost to replace the blowers is \$220,000.

- There are two (2) sludge transfer pumps that are used to transfer the sludge between the two-stage system and to move the sludge from the digesters to the biosolids storage tanks. The pumps and motors were installed in 1996 and are rated at 23L/s at a TDH of 7.5m. The transfer pumps and motors are in good condition. The useful life of small pumps is estimated to be 30 years. It is recommended that the pumps be replaced within the next five (5) to ten (10) years. The cost to replace the pumps and motors is estimated to be \$60,000.

- The digesters are also equipped with one (1) decanting pump and motor. The pump and motor are electrically driven and is rated at 23L/s at 7.5m TDH. Supernatant is removed from the aerobic digester and biosolids tanks and discharged to the aeration tank influent channel. The pump and motor were installed in 1996 and appear to be in good condition. The useful life of small pumps is estimated to be 30 years. It is recommended that the pumps be replaced within the next five (5) to ten (10) years. The cost to replace the pump and motor is estimated to be \$30,000.

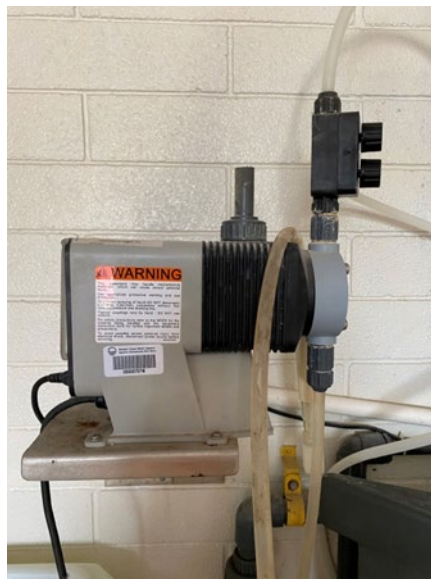
**Figure 9 – Sodium Hypochlorite Chemical Dosing Pump**

- Structural
  - The chemical storage room appeared to be in good condition. No upgrades are recommended at this time.

- The plant is equipped with two (2) 400L sodium hypochlorite storage tanks that appear to be in good condition.
- There are three (3) positive displacement chemical metering pumps (2 duty, 1 standby). The pumps are electrically driven and are rated for a flow of 9.1L/hr at a discharge pressure of 1,035kPa. The pumps appear to be in good condition. There are no upgrade recommendations at the time of inspection.
- The chemical dosing system pipes and valves appear to be in good condition. No upgrades are recommended.
- The sodium hypochlorite chemical dosing system is a back-up method if UV fails.
