July 26, 2022  
Our File: 222042

Re: Slope Review  
Proposed Severances  
343019 Side Road 23  
Municipality of Meaford

This follow-up letter report provides a review of the current slope conditions, comments on some preliminary modelling, and comments with respect to the proposed development.

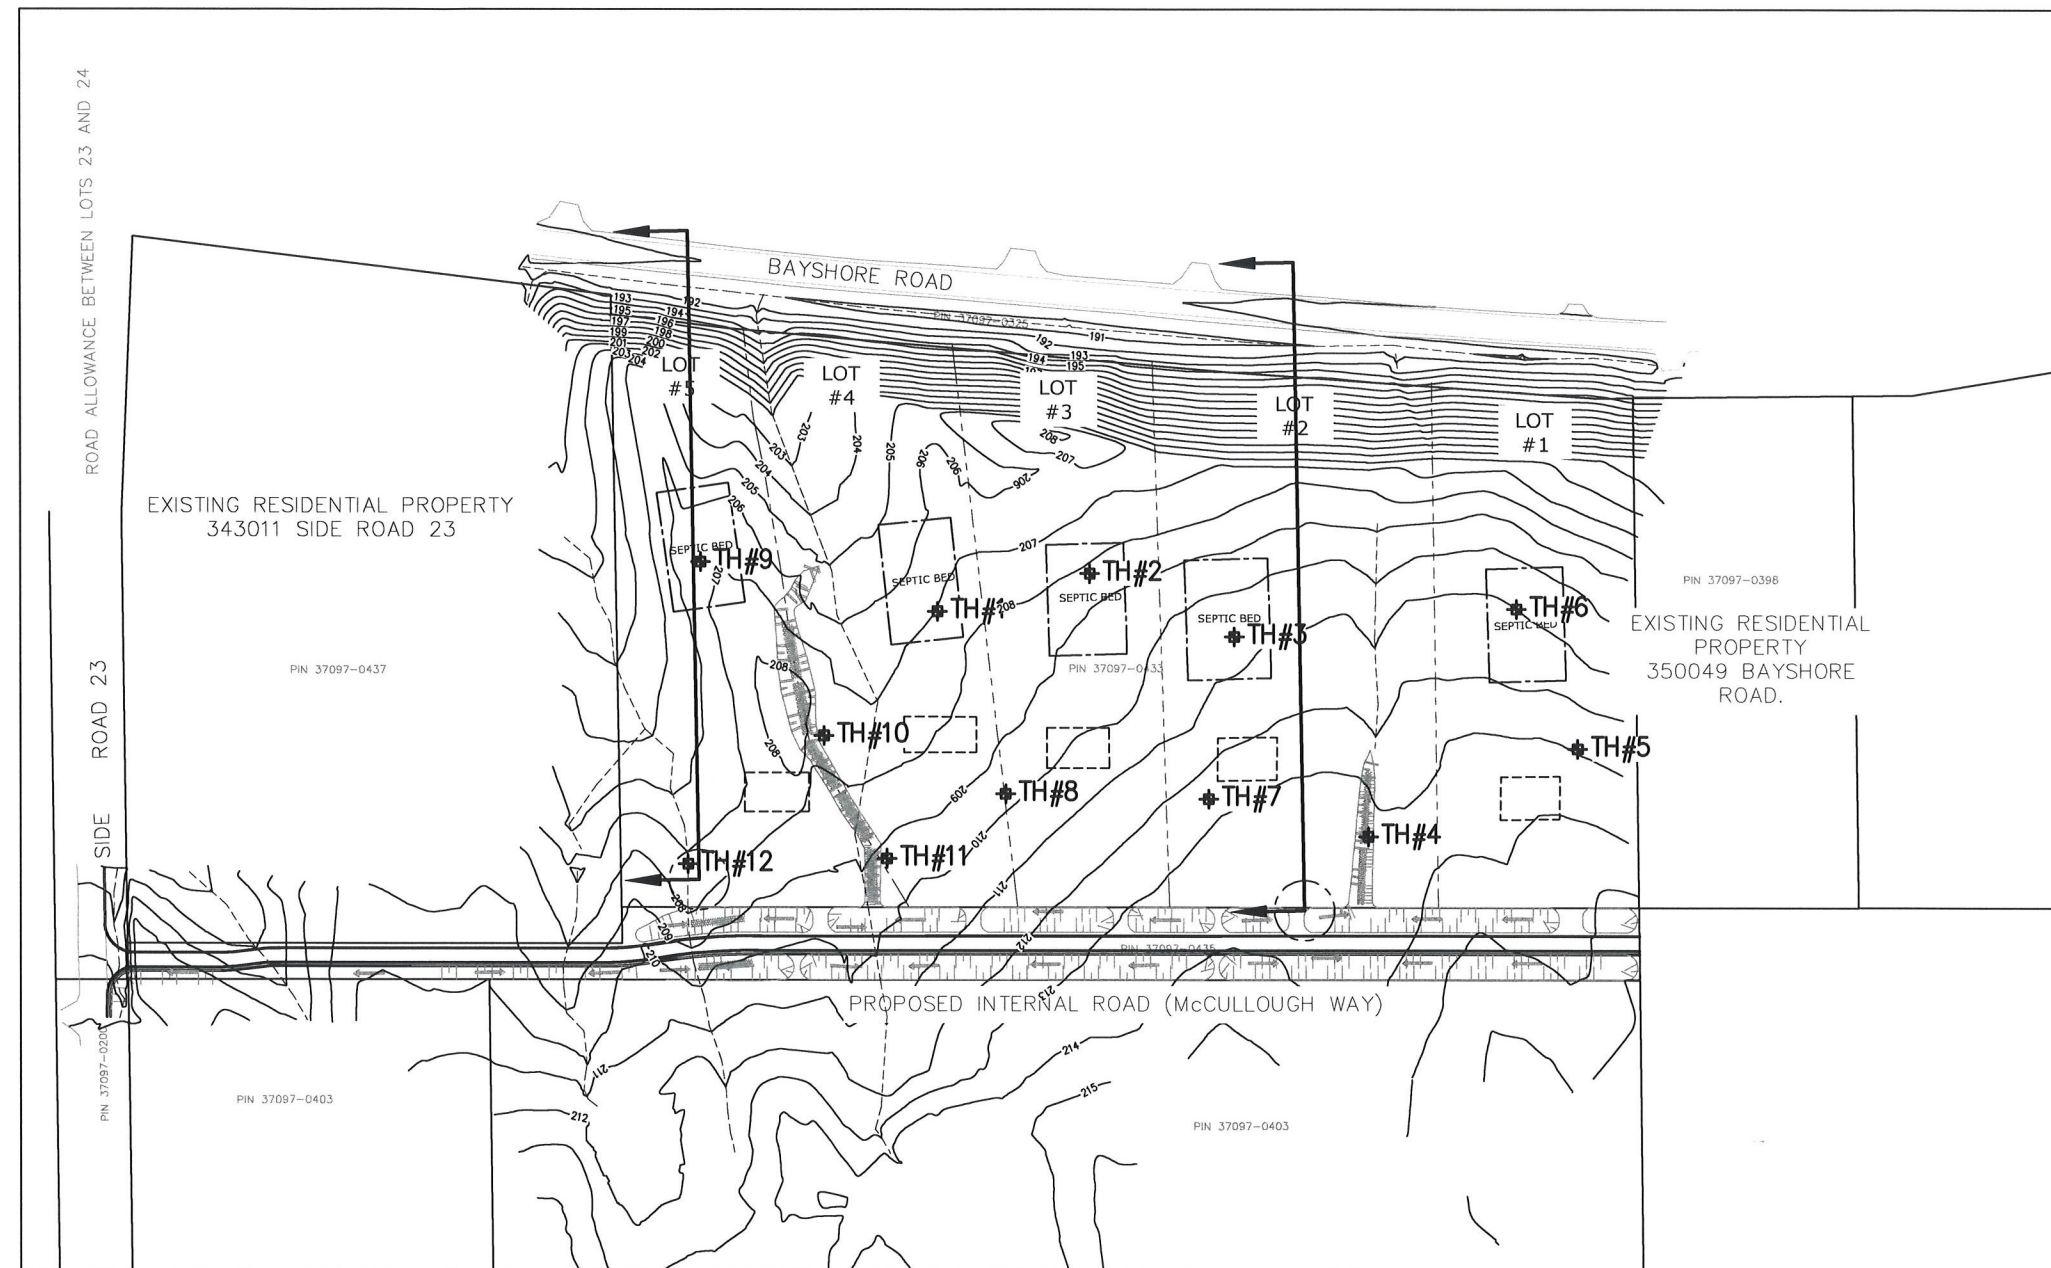
The subsurface information gathered from the previous site investigation in combination with the topographical survey information provided from Crozier was used to conduct preliminary slope stability modelling. The cross-section locations are identified on Figure No. 1 and the cross-sections are shown on Figure No. 2.

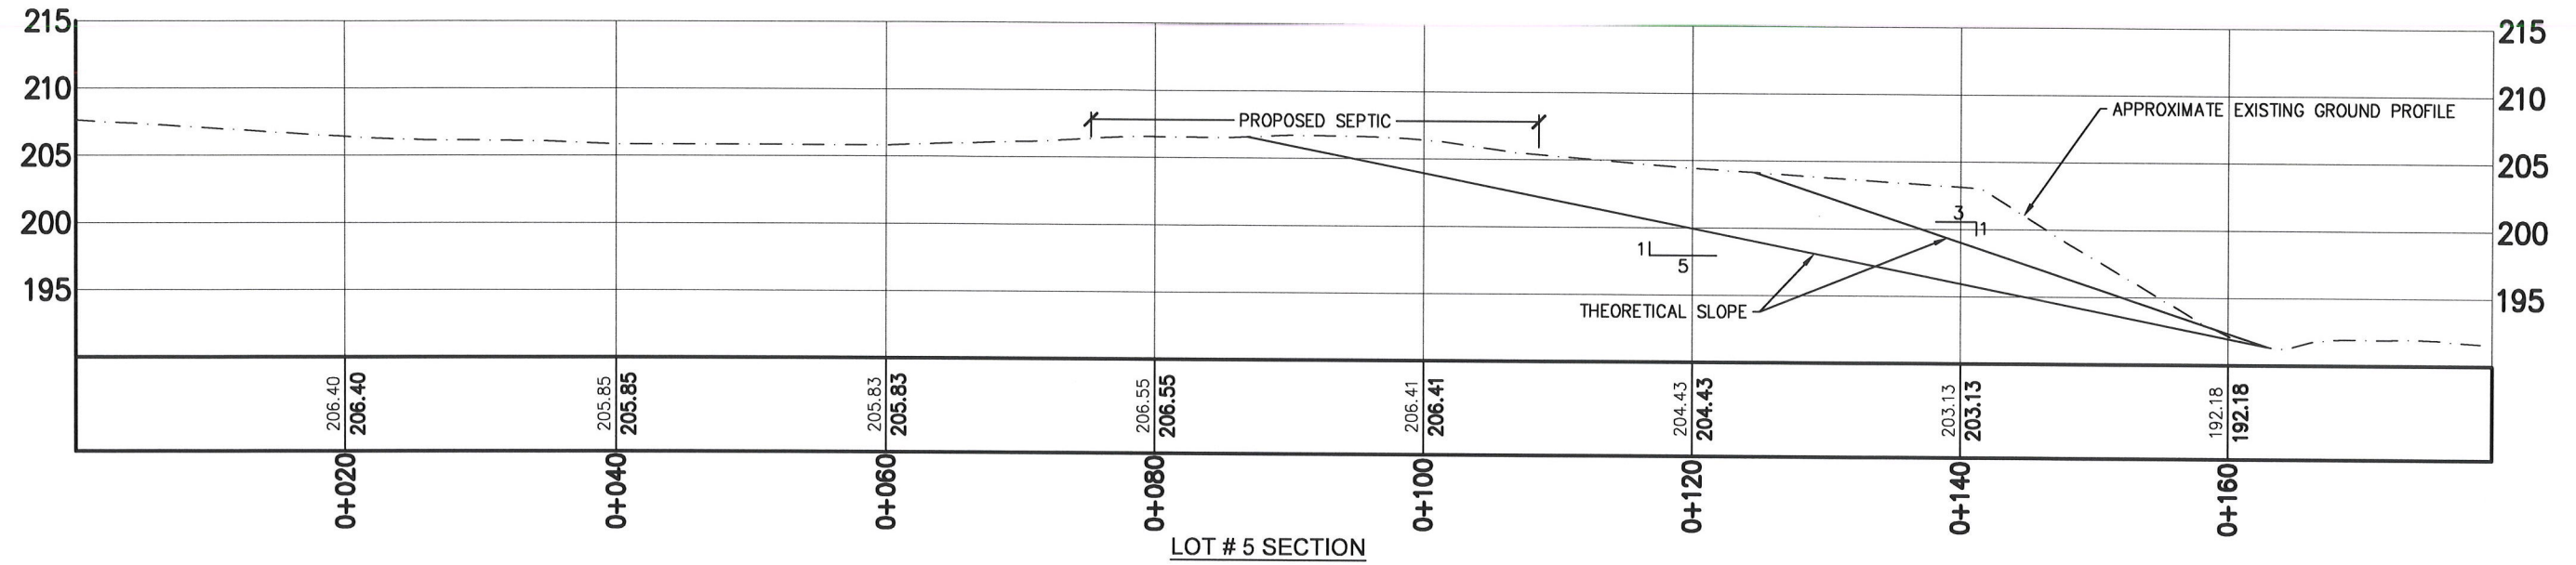
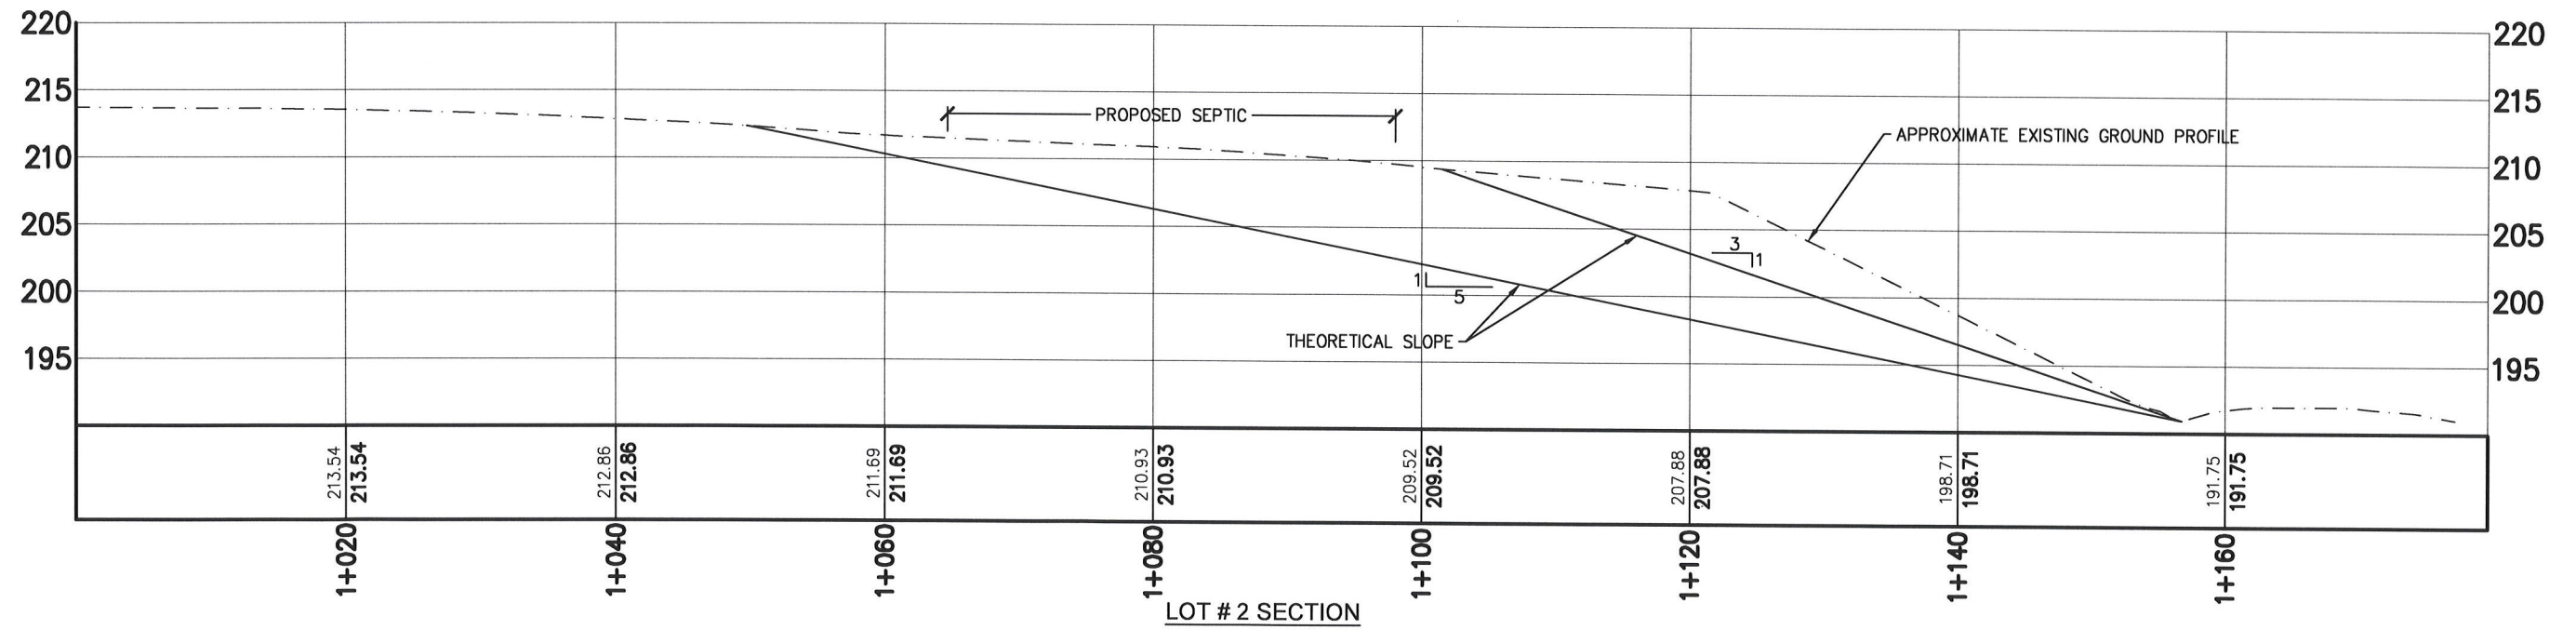
Figure No. 2

The groundwater table was modelled at the interface of the clayey silt till and the underlying clay and shale. Through the various iterations of the modelling, it was determined that if slippage were to occur, it would likely be near the surface and towards the bottom of the slope. The lowest Factor of Safety produced in analysis was 1.04 and 1.11 at Lot 2 and Lot 5 respectively. Given the vegetative growth on the slope, the slope is considered to be stable. For the larger deep-seated failures of the slope, the initial modelling identified Factors of Safety in the order of 1.4 to 1.5 which are considered acceptable for long-term development.

Based on the interpreted soil conditions, slope geometry, initial modelling results and the proposed setbacks, it is our opinion that the proposed development will not impact the long-term stability of the slope. For long term protection and conservative development practices, within the 3 to 1 influence zone, only minimal grading should occur, and no landscaping or placement of fill should proceed within 10m of the top of the slope. The slope is to remain forested to minimize erosion.
