# **Memorial Park Master Plan**

## **Municipality of Meaford**

**October 2021  
300043326.0000**

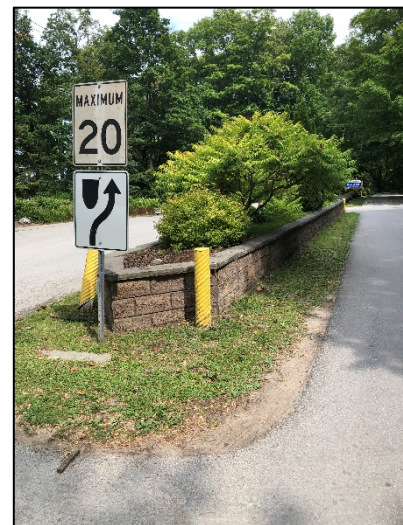
- The entrance garden is constructed from architectural concrete blocks and is approximately 600 mm above grade. The garden wall’s foundation type and condition are unknown but since the garden wall is showing signs of failure and many sections are out of plumb, it is suggested that further analysis or investigation of this foundation is required.

- The concrete filled bollards protecting each end of the wall have been subject to significant impact in the past; some are bent and no longer offer optimum protection to the raised garden wall. There is no curb between the roadway pavement and the grass strip beside the garden wall.

- Adjacent roadway asphalt edges are failing and the grass surrounding the planter is distressed possibly due to poor drainage and/or vehicular and pedestrian traffic. The wall may act as a “pinch point” for pedestrians walking beside the road when traffic is present.
- There is no lighting within the garden space at present.

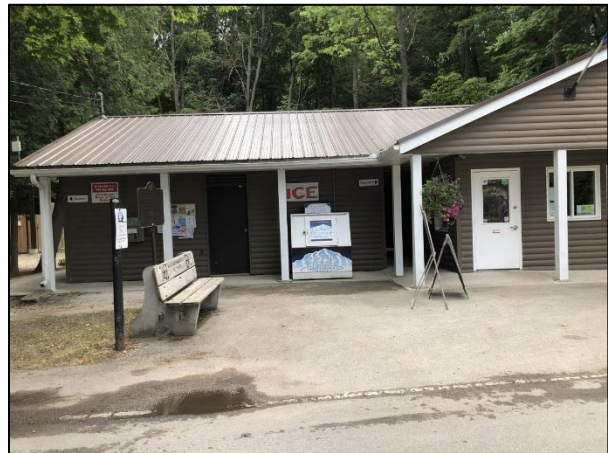
- It was also noted that there was no protection between vehicles that pull up beside the office and pedestrians travelling along the building. Concrete barrier curbs, bollards or other protection devices between the vehicular traffic lane and the pedestrian access routes would provide pedestrian protection in selected areas.

- Concrete pathways to the accessible washroom are obstructed by trip hazards such as doorsteps and uneven/rutted pathways and blocked by a large icebox. The width of the concrete pathway could be a limiting factor for barrier free access, as well, the grading at the south end of the concrete walkway is too steep and parking access is very limited. There is no signage to identify the Park's available AODA compliant facilities, and a review of the current lighting may reveal that additional lighting is necessary.

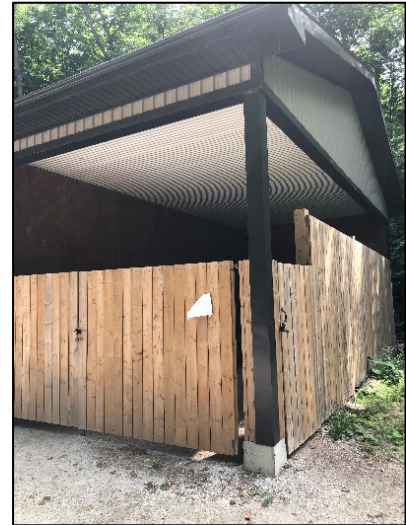
- The main workshop area is not fitted with any overhead cranes or lifting devices, thus being used for storage and minor equipment repair and maintenance only. Heating and washroom facilities were not observed within the workshop.

- We highly recommend that doors be left open if any vehicles or machines are running while in the workshop to mitigate the effects of exhaust fumes inside the building.

- No bollards exist on either side of the overhead doors, which, if installed, would offer some protection against exterior vehicle impact.

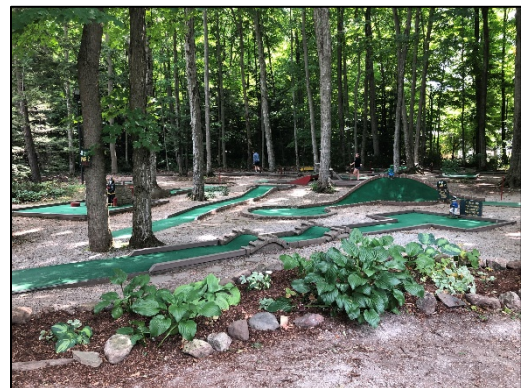
- The 18-hole mini-golf course is located in the wooded area behind the Park Office.
- The course is aging and is in need of general upgrading.
- This area is under tree cover. Existing infrastructure for lighting is present but rarely used as the park office closes at 9 p.m. and mini-golf is not permitted past 8:30 p.m.
- The pathways between the various mini-golf holes are natural ground and not covered with a material such as stone dust, paving or concrete that would provide a suitable walkway surface during all weather conditions. The existing surface is not accessible.
- Parking in this area is shared with the Park Office and is limited.

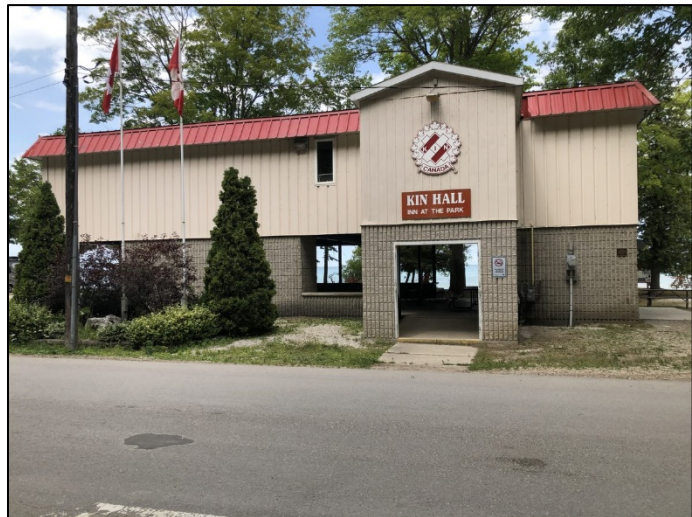
- There was a small metal canopy/awning over a lower level window that is unstable and unsafe due to its condition and the type of fasteners used to attach the canopy to the block

wall of the building. Since the time of Burnside's staff visit, we have received verbal indication that the awning has been removed.

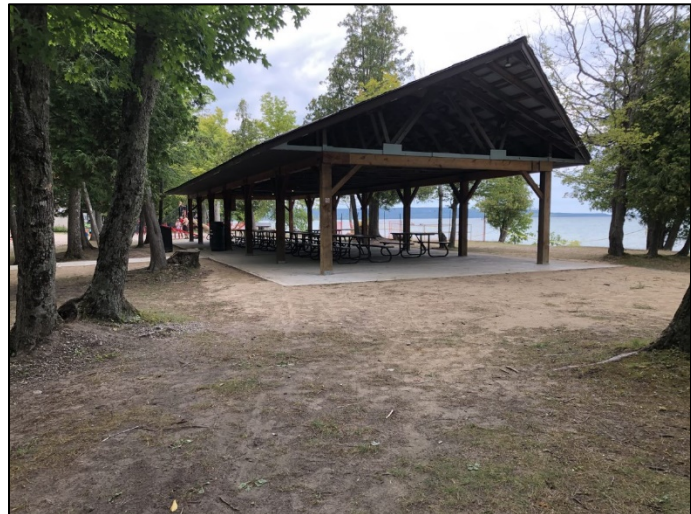
- The Beach Pavilion is a heavy timber knee braced column structure with perimeter wood beams. The roof is a gable style roof with extended roof overhangs at the gable ends of the building constructed from lumber roof trusses. The trusses have nailed plywood gussets at the joints that were observed to have some weathering but appear to be performing satisfactorily. The roof cladding is sheet steel on lumber purlins and is in good condition.
- The heavy timber components were recently replaced along with the concrete floor slab. The floor connects the Pavilion to the Beach Washroom and serves as a walkway to the Beach Lookout Pad.
- The current lighting consists of basic incandescent lighting located down the center of the interior roof line and its adequacy should be confirmed.

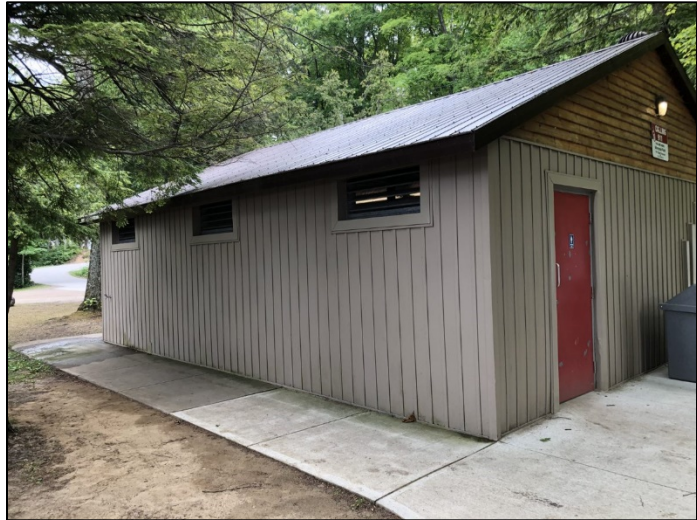
- This 70 sq.m (750 sq.ft) Beach Washroom building was constructed in 1958 and consists of public washrooms and a service room. The building's roof structure is metal cladding on conventional sloped wood framing rafters and tie members. The exterior material is vinyl siding and wood siding at the gable ends, both of which are in good condition with only the wood siding requiring new paint. There is no ceiling in the service area of the building.

- The washroom interior is basic with painted concrete block walls and a painted floor slab.
- An AODA report, prepared previously through a separate study, indicates that these washroom facilities are partially compliant with today's standards, but many details and fixtures require upgrading to be fully compliant, including exterior door widths. There are no shower facilities within the washroom, nor are there any full-size change tables for infants and dedicated "change-room" facilities.

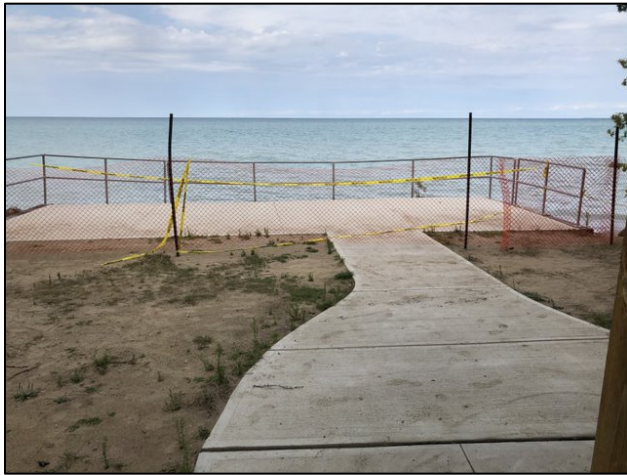
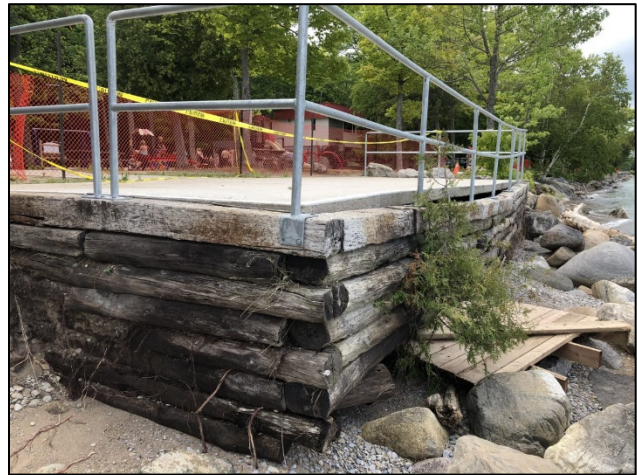
- Until August 2019, a beach lookout pad was located north of the beach Pavilion but was impacted by the highwater levels of Georgian Bay (the Bay) and had to be removed.
- Access to the lookout pad was delineated by a walkway from the Pavilion.
- Given the continued high water levels, there is no immediate plan to reconstruct this feature. If water levels lower in the future, the Municipality may consider conducting detailed studies to determine how accessible beach access can be provided.

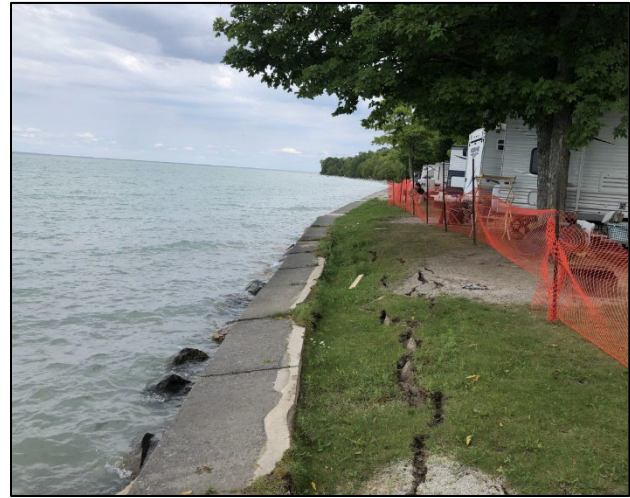
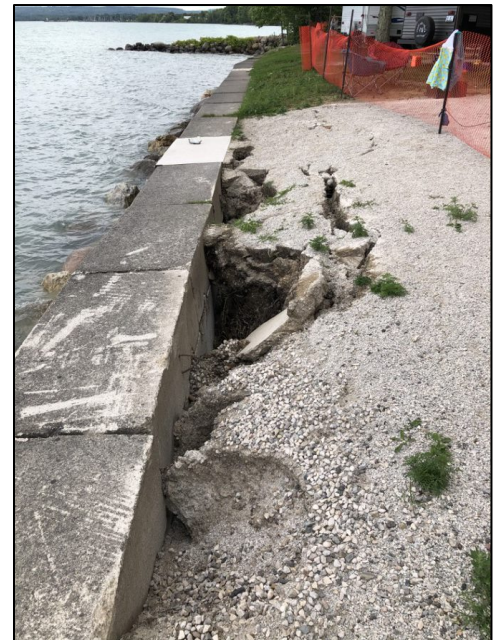
- Rising water levels and storm events damaged the retaining wall and the wall failed, limiting the use of waterfront campsites (#1-18).
- At the time of Burnside's visit, no guardrails existed along the wall and the wall height exceeds 1,000 mm over much of its length<sup>5</sup>. This presents a Health and Safety hazard for campers and vehicles parked in campsites #1-18. Beyond a temporary safety fence which was recently erected, there are no permanent safety features to prevent vehicles from backing up too close to the retaining wall edge or to prevent pedestrian missteps and falls.

- A detailed review of the retaining wall is presented in Appendix A.
- Since Burnside's visit, the Municipality has completed work to address problems with the retaining wall. None of the work undertaken has been inspected by Burnside; however, details about the rehabilitation can be found in Appendix A.

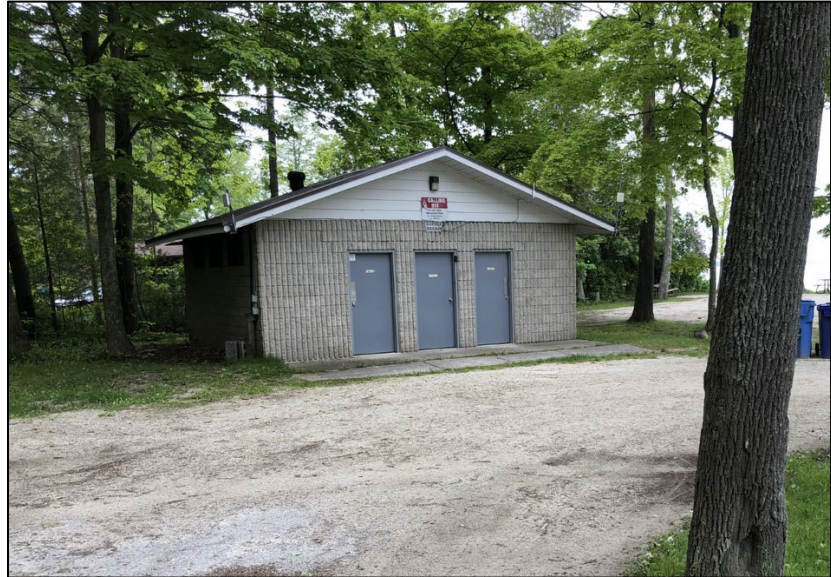
- The Lower West Washroom is located in the south west corner of the Upper Campground on the south side of the Lower Campsite access road, across from campsite #30. According to the BCA, this washroom facility was constructed in 1978. The exterior walls of the washroom are ribbed architectural concrete block and the roof is a wood framed gable style with steel sheet roof cladding.
- The exterior of the building has significant masonry joint step cracks in several walls, and the cause is presently unknown without further investigation. It is unknown if the structure is reinforced with vertical reinforcing in the masonry cores or contains horizontal masonry joint wire reinforcing for crack control.
- This building is not compliant with current AODA standards, as per the BCA and AODA reports.

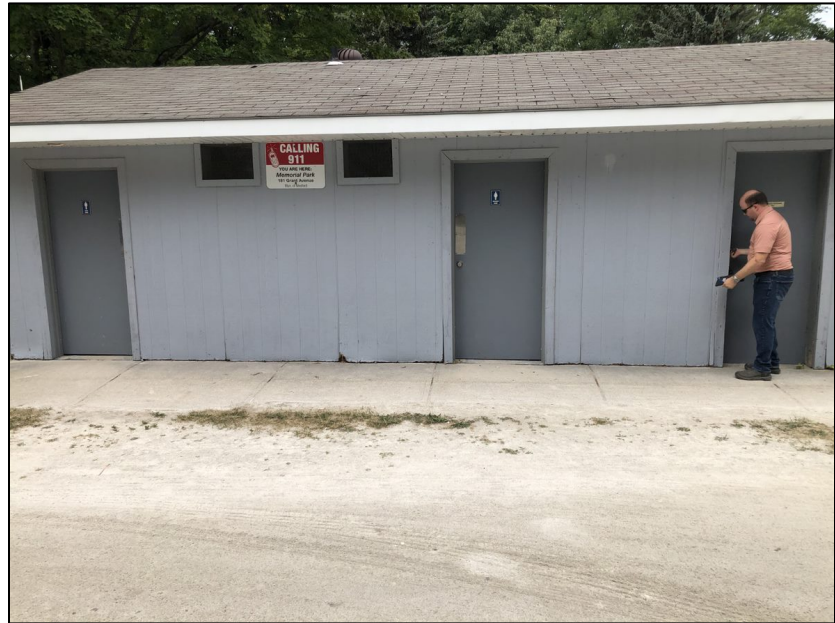
- The Lower Kin Washrooms are located at the North end of the Lower Campground, adjacent to campsites #70 and #111. The building is a simple structure, 45 sq.m (480 sq.ft)., constructed in 1970, containing a men's and women's washroom, and a storage room. Exterior walls are concrete block clad with a painted wood type paneling, which is showing signs of deterioration. The roof is wood framed with asphalt shingles. Access to the washroom facility is a concrete walk along the front of the building beside the gravel campground road. The building appears to be in sound structural condition.
- On the interior of the building is a ceramic tile floor, painted block walls and a painted ceiling. The washrooms are not ventilated or heated and there is no hot water. The washroom stalls are accessible as barrier-free but are not fully compliant to today's AODA standards.

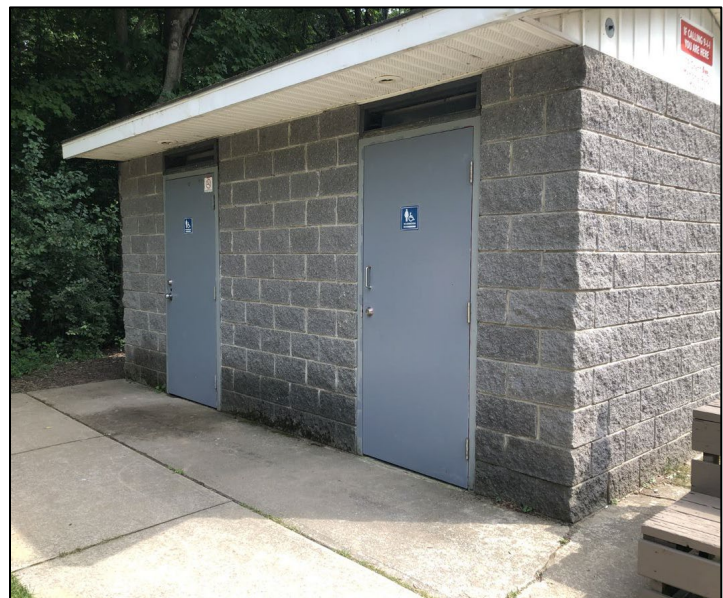
- The Horseshoe Pit Washrooms are located at the Horseshoe Pit on the east side of the Upper Campground. The building was constructed in 1995 and contains two gender specific washrooms. The building exterior consists of split faced architectural concrete blocks with a gable styled shingled roof. Interior walls are painted block walls with ceramic tiled floors and a painted wood ceiling.
- The structure is in good condition; however, the north exterior wall is

damp and has what could be moss/mold growth on it, which likely can be easily cleaned.

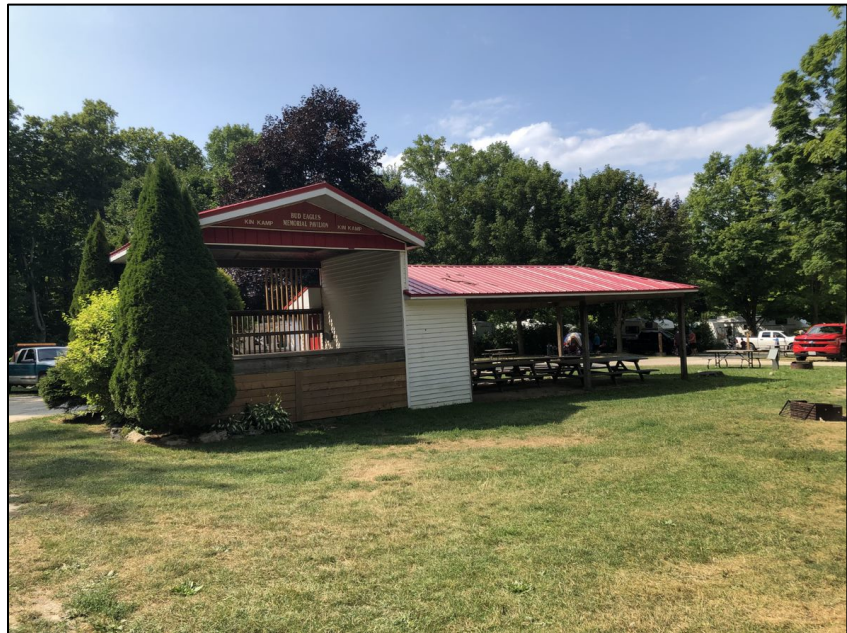
- The Bud Eagles Memorial Pavilion and Amphitheatre is located on the south end of the Upper Campground, across the campground road from the Upper Kin Washroom. The structure is a wood framed outdoor stage and covered area containing some picnic tables. The roof of the structure is sheet steel clad. This area is most utilized during Memorial the Kinsmen's "Kin Kamp" weekend.

- Although there was no BCA report completed for this structure, the initial exterior review indicated that it is in good condition, however further examination below the stage area is required to determine if there is any material degradation, possibly due to moisture and the amount of ventilation available to reduce moisture content in the wood structure. It is also unknown to what load capacity the stage floor has been designed.

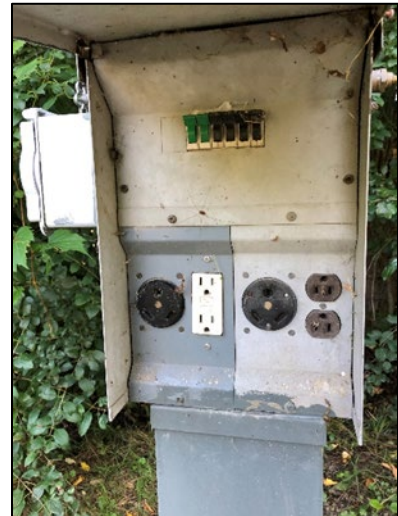
- The RV power connection boxes are old and do not appear to be protected by a Ground Fault Circuit Interrupter (GFCI) as required by the Electrical Code.

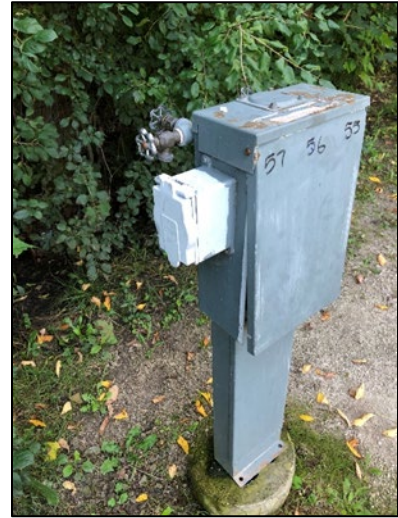
- A 167-kVA pad-mounted single phase 120/240 V transformer provides electricity for all facilities and campsites in the Upper Campground area. There is a separate hydro meter for this area and an 800A/120-240 V switchboard distributes power to the individual campsites and facility buildings.
- A switchboard and a panel board are located inside the Upper Kin Comfort Station on the south end of the Upper Campground area. The Lower Kin Washroom on the north side of the Upper Campground area has its own panel board. Panel boards are in good condition; however, further review is recommended as part of any electrical system upgrades or expansion.
- RV power connection boxes are provided for the full-service campsites. These boxes are old and do not appear to be protected by a Ground Fault Circuit Interrupter (GFCI) as required by the Electrical Code.

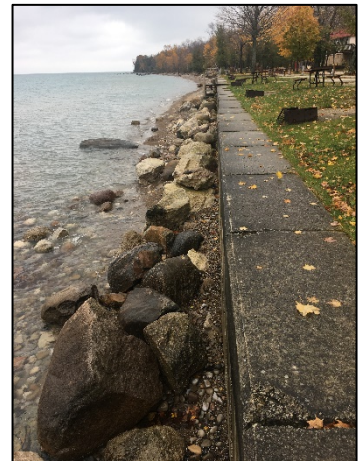
Natural stone of various sizes had been placed on the water side of the retaining wall at the time of its construction, estimated to be in the early 1980's. At the time of the retaining wall installation the water level in Georgian Bay was lower than its current level. Additional natural stone may have been placed at different times since the original construction although the records are not complete.

Burnside staff visited the site in December 2018 to observe the initial stages of retaining wall failure.
