# Phase I Environmental Site Assessment, 206105 Highway 26, Meaford, Ontario

**M1 Development Inc.**

**Golder Associates Ltd.**

February 24, 2020

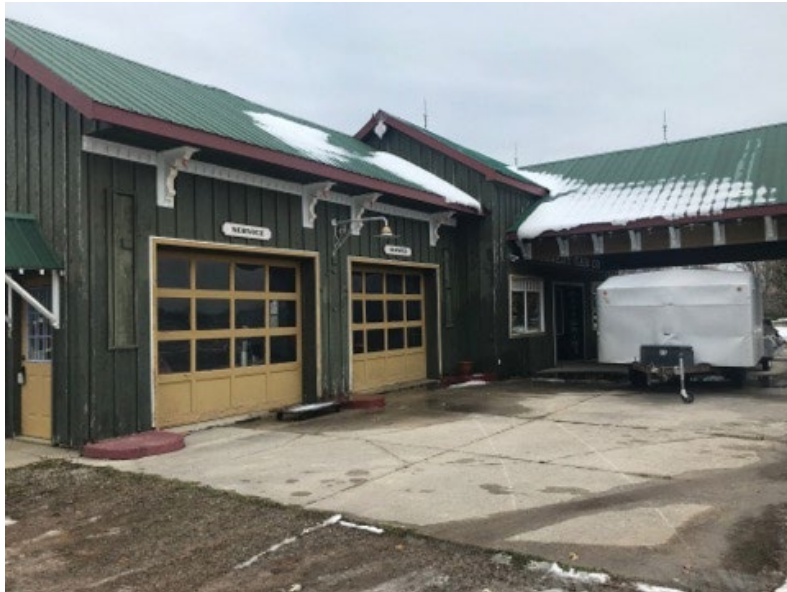
Photo 7– View of Building B, facing northeast. Note: service garages.

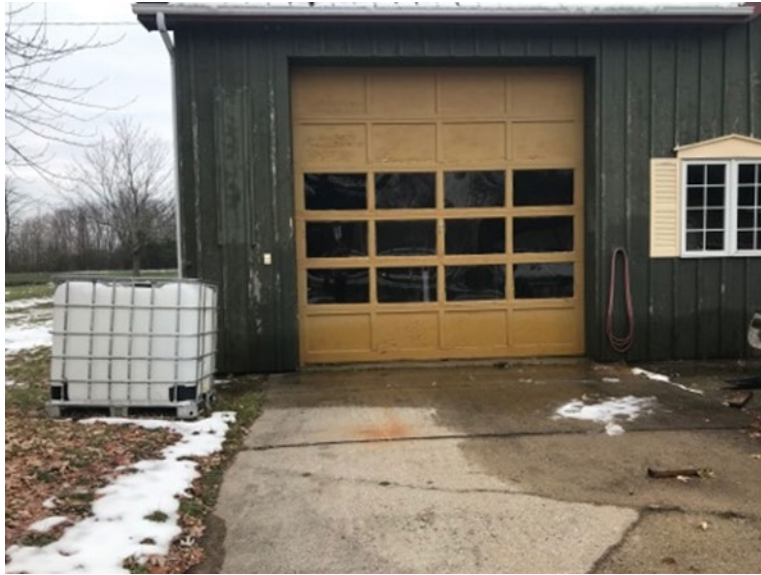
| General Description | Findings and Assessor Comments |
|---|---|
| Unidentified substances | One empty white storage tank was observed outside Building B by the service door. |
| Spills and/or staining | <b>Building A:</b> None observed.<br><b>Building B:</b> Brown stained concrete observed outside Building B in front the service doors.<br><b>Building C:</b> Cracked concrete with staining observed.<br><b>Building D:</b> None observed.<br><b>Building E:</b> Cracked concrete with staining observed.<br><b>Building F:</b> None observed. |

Photo 9 – View of Building B. facing east. Note: brown staining on concrete and empty storage tank.

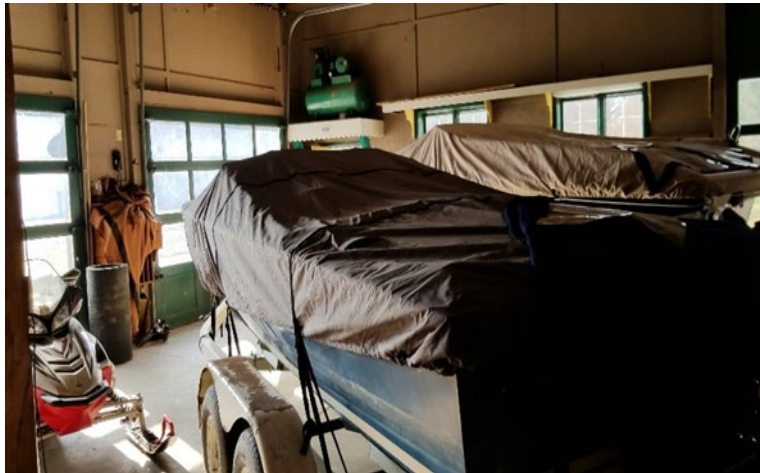
Photo 10 – View of the garage portion of Building B utilized for storage.

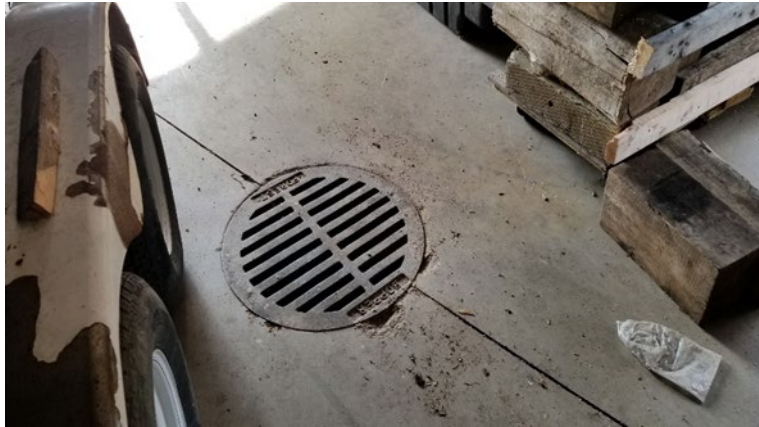
| Waste Generation | Description |
|---|---|
| Lagoons, drains, sumps, pits, and oil-water separators | One floor drain observed in the garage portion of Building B. |

- Former vehicle maintenance/service garages – Two former garages are located in the central portion of the Site. One of the garages (Building B) contains a floor drain in the central portion of the garage that flows to an unspecified location. Stained concrete was identified at the other garage (Building C) with visible concrete cracks providing a potential pathway for contamination to migration to the subsoil.

Photo 11 – Floor drain noted in the center portion of the garage in Building B.

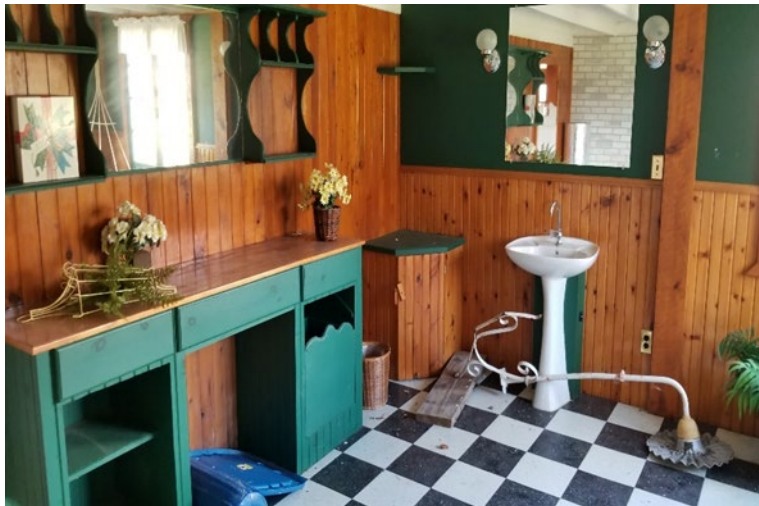
Based on the age of Site Building A (1920's), building materials may include friable ACMs. The Site Representative stated that asbestos was not known to be present at the Site; however, during the Site visit vinyl flooring tiles, potentially containing friable ACMs, were observed in Building B.

Photo 12 – Interior view of Building B. Note: potential vinyl floor tiles containing asbestos.

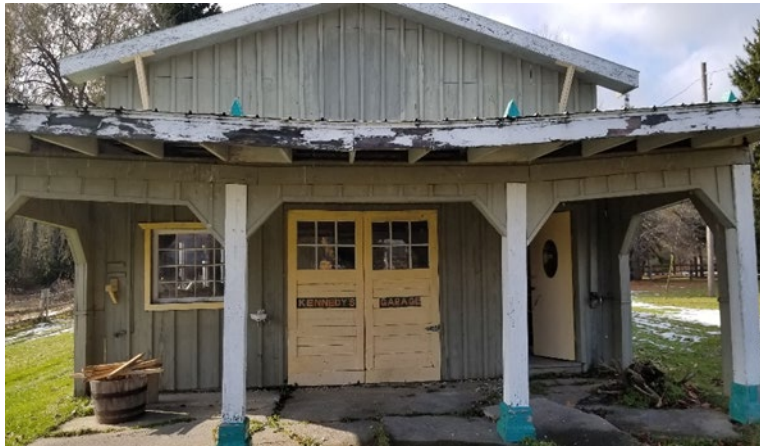
Photo 14 – View of Building C used for storage, facing west.  
Note: suspected former vehicle maintenance/service garage

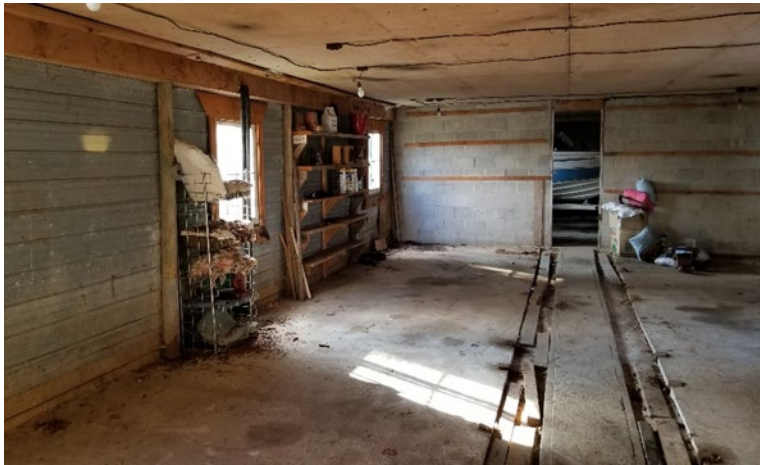
Photo 15—Interior view of Building C. Note: cracked concrete and staining.

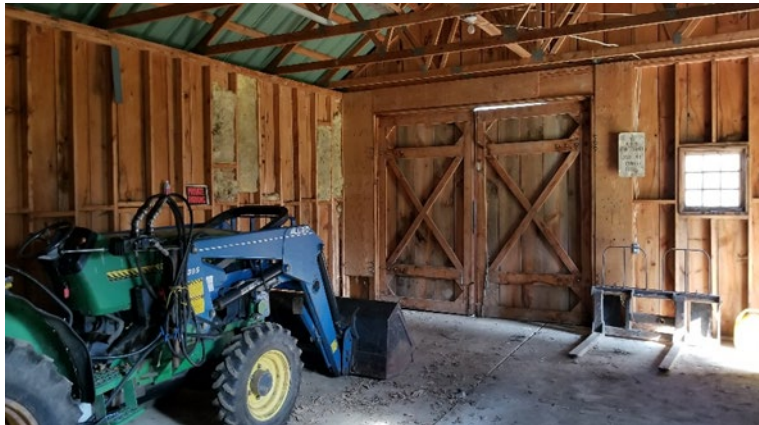
| Buildings | |
|---|---|
| Hydraulic lift equipment | One vehicle jack was observed in Building B. One tractor was noted in Building E. |

Photo 19– Interior view of Building E. Note: heavy equipment storage.

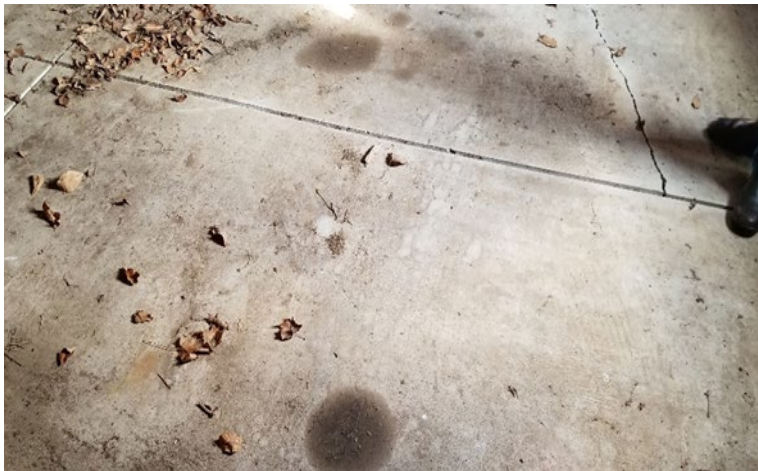
Photo 20 – Interior view of Building E. Note: cracked concrete and staining.
